**To:** Logan Perron, District 7 Project Manager  
*CEE*

**From:** Callie Ewald, PE, Senior Geotechnical Engineer

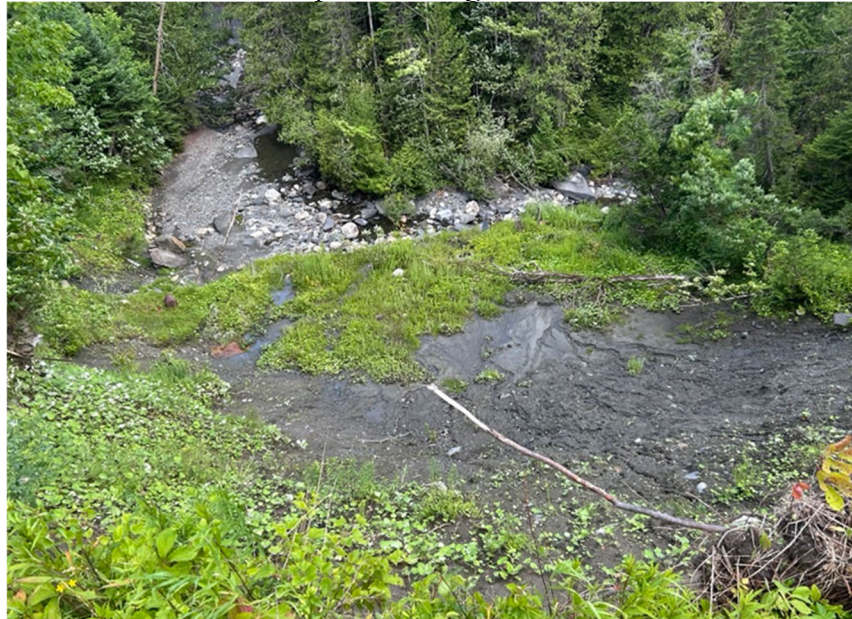
In terms of an immediate response, it is our understanding that Keith plans to install signs to notify the public of the unstable area. I recommend monitoring the area, specifically the vegetated area above the crest, the guard rail, and the roadway. Additional cracks can sometimes develop behind a scarp, indicating movement and instability of the material near the crest of the slope. The area should be monitored visually weekly and after high rain events for cracking/deformation in the pavement and dipping of the guard rail. Based on the distance from the crest and the very dense material, I would not expect to see any deformation in the roadway in the short term.
